PIPELINE ACCIDENT REPORT

MID-AMERICA PIPELINE SYSTEM
LIQUEFIED PETROLEUM GAS PIPELINE
RUPTURE AND FIRE
DONNELLSON, IOWA
AUGUST 4, 1978

1. Report No. NTSB-PAR-79-1		2. Government Accession No.		3. Recipient's Catalog No.	
4. Title and Subtitle Pipeline Accident Report -- Mid-America Pipeline System Liquefied Petroleum Gas Pipeline Rupture and Fire, Donnellson, Iowa, August 4, 1978				5. Report Date May 3, 1979

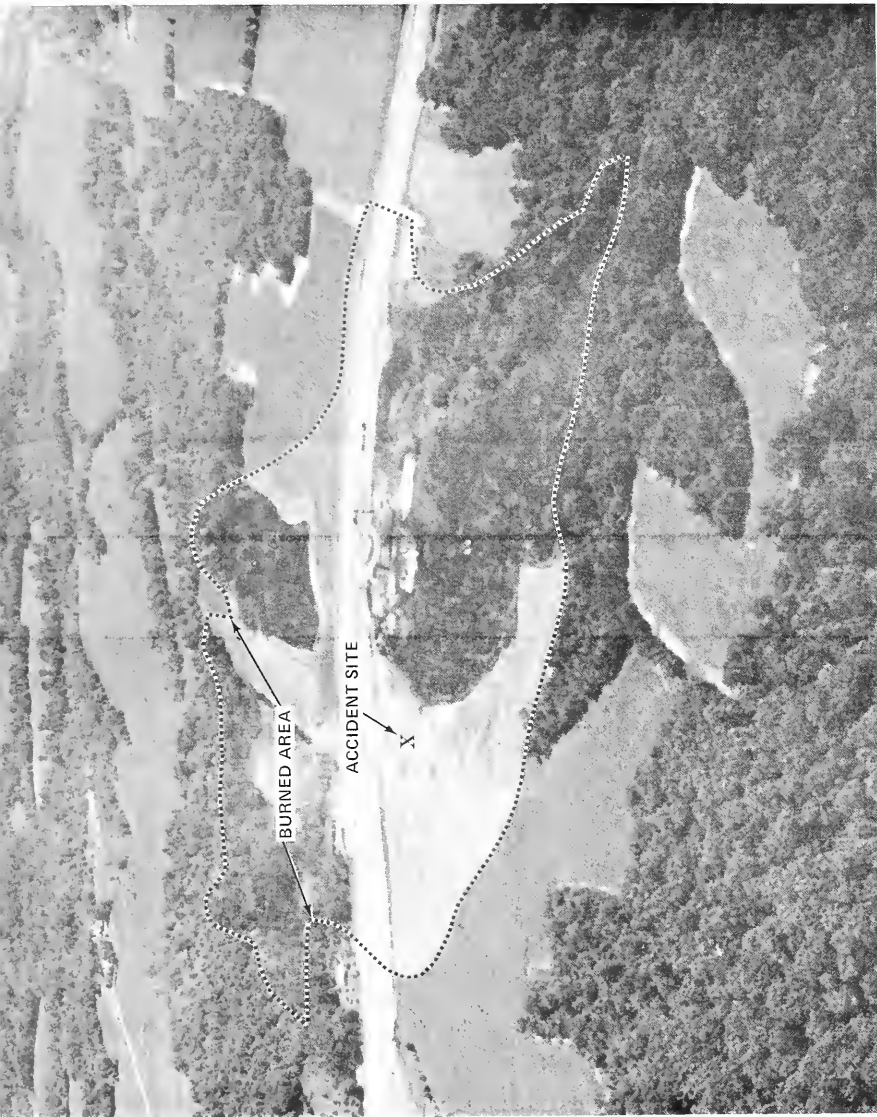
firefighters found the farmhouse had already been leveled by the intense fire and there was a towering column of fire about 400 feet high located in a cornfield north of the farmhouse. Between 12:20 and 12:25 a.m., the Donnellson, Iowa Volunteer Fire Department arrived at the scene and both departments began extinguishing numerous brush fires. (See figure 1.)

Figure 1. View of the burned area.

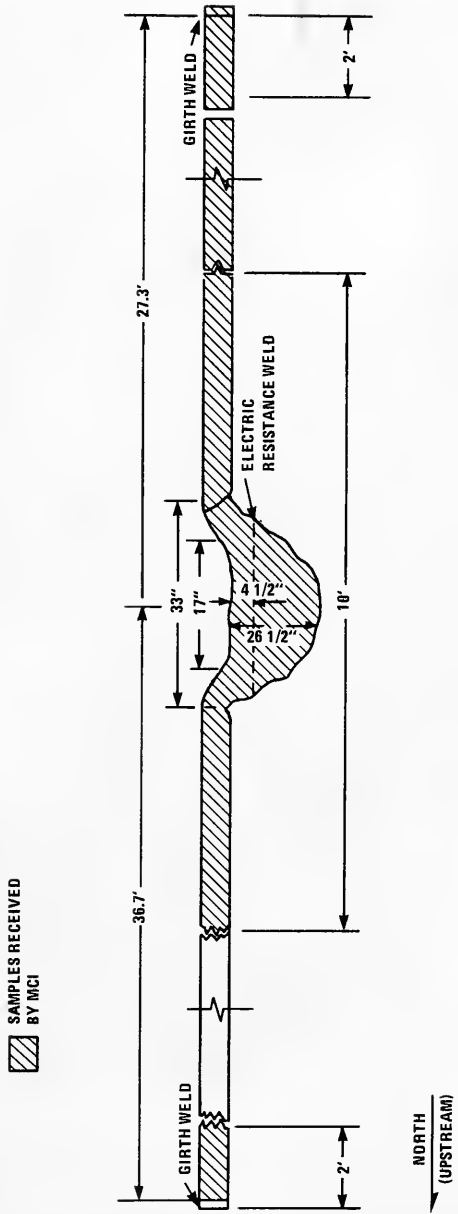
A segment of 8-inch pipe approximately 64 feet long containing the 3-foot ruptured section was removed from the system. (See figure 3.) Approximately 3,750 barrels (157,500 gallons) of liquid propane had vaporized and burned.

Figure 3. An 8-inch segment of pipe containing the 3-foot ruptured section.

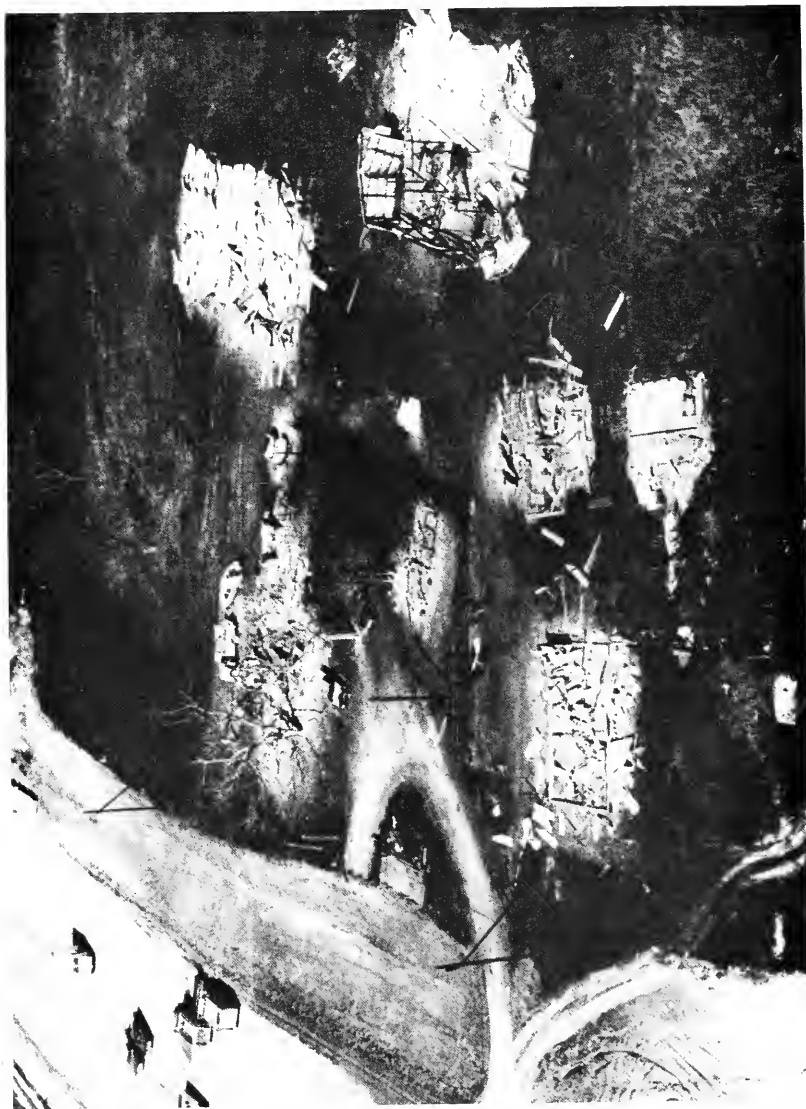
One farmhouse, six outbuildings, and an automobile were destroyed (see figure 4), and two houses and an automobile were damaged by the fire. Electric power lines and telephone lines were burned down and approximately 75 acres of woods and cornfields were burned.

Figure 4. An aerial view of the farmhouses and other outbuildings destroyed.

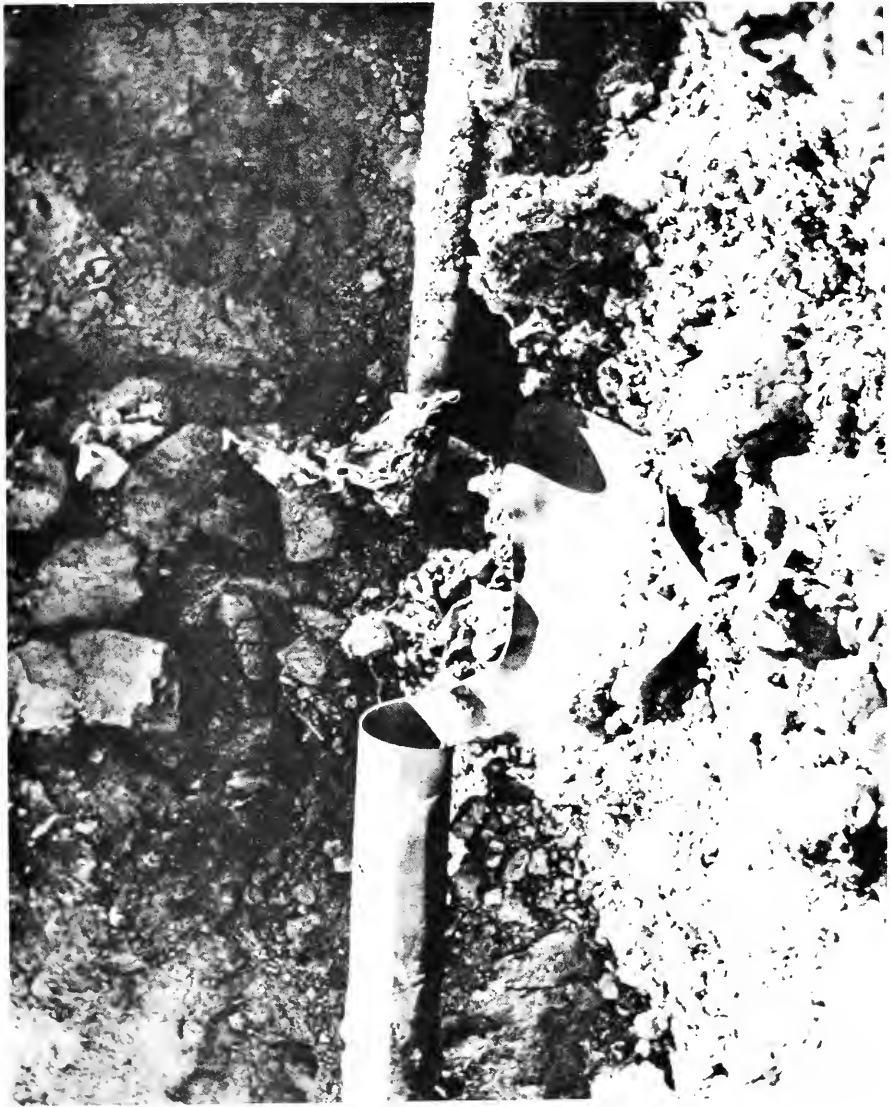
On August 4, 1978, a 64-foot section of pipe was removed at the rupture site. Three samples were cut from the section for metallurgical analysis and examination: a 10-foot section which contained the failure, and two 2-foot pieces from each end of the failed length of pipe. (See figure 6.) The Safety Board retained Metallurgical Consultants, Inc., of Houston, Texas, to conduct testing and metallurgical analysis of the failed pipe.

Figure 6. Drawing showing details of ruptured pipe and location of samples.

The metallurgical examination concluded that the failure of the pipe was caused by external mechanical damage in the form of a dent and a gouge. The damage was located at the 4 o'clock position in the pipe. The damaged section was relatively small and would have been difficult to detect with the naked eye. Because of fire damage to the pipe, it was impossible to determine whether the dent and gouge occurred before or after coating operations. (See appendix A.)

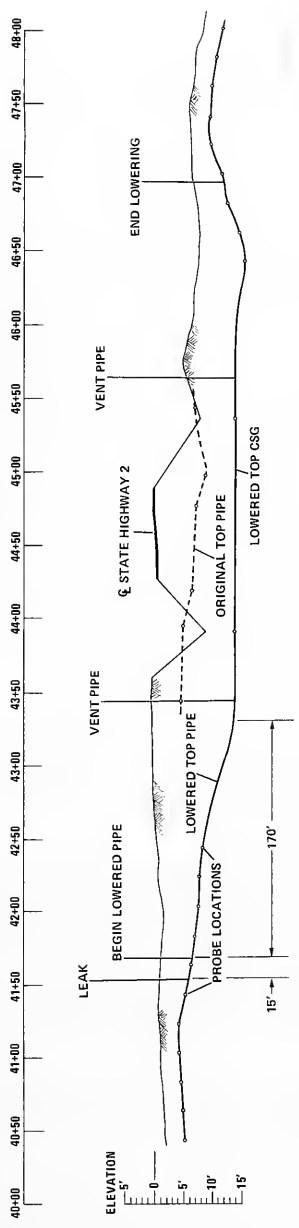
Three months before the accident, MAPCO completed lowering a section of the Farmington lateral under Highway 2 adjacent to the accident site. (See figure 7.) After the accident, it was determined that MAPCO had started lowering the pipeline 15 feet from where the rupture occurred and the pipe elevation had changed 10 feet along 170 feet of pipe north from that point.

Figure 7. Drawing showing elevation of pipeline.

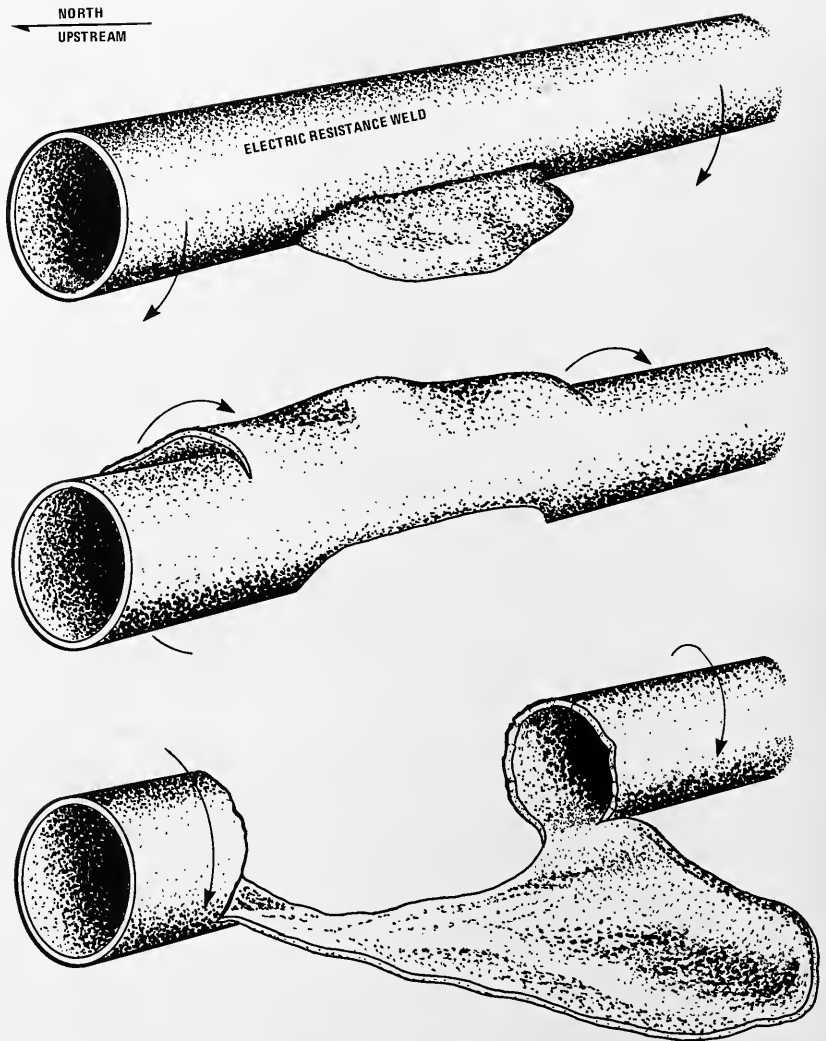
The rupture was approximately 33 inches long and originated on the west side of the line. It propagated longitudinally about 17 inches and then spiralled over 360 degrees at each end and stopped. The failed section created by the force of the failure as the pipe wall was blown outward below the fracture traveled under and around the pipe. (See figure 8.) Close examination of the outside surface showed gouge marks along and on either side of the fracture. The most severe gouge was approximately 7 1/2 inches long and 1/4 inch wide and located along the bottom side of the fracture. (See figure 9.) The fracture surfaces near the center of this gouge were very flat and brittle--appearing over a length of about 2 1/2 inches. The fracture changed from flat to approximately 45 degrees with the typical appearance of shear. The fracture surface also reveals an irregular fracture profile with fine cracks on each side of the fracture. The depth of the gouge was approximately 0.005 to 0.007 inch.

Figure 8. Drawings showing how "flap" was blown out and around the pipe ending up on the west side of the line.

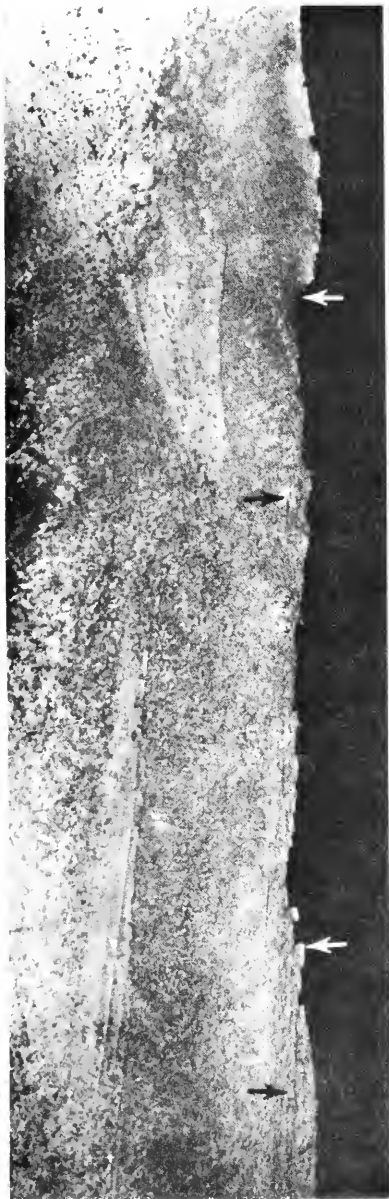
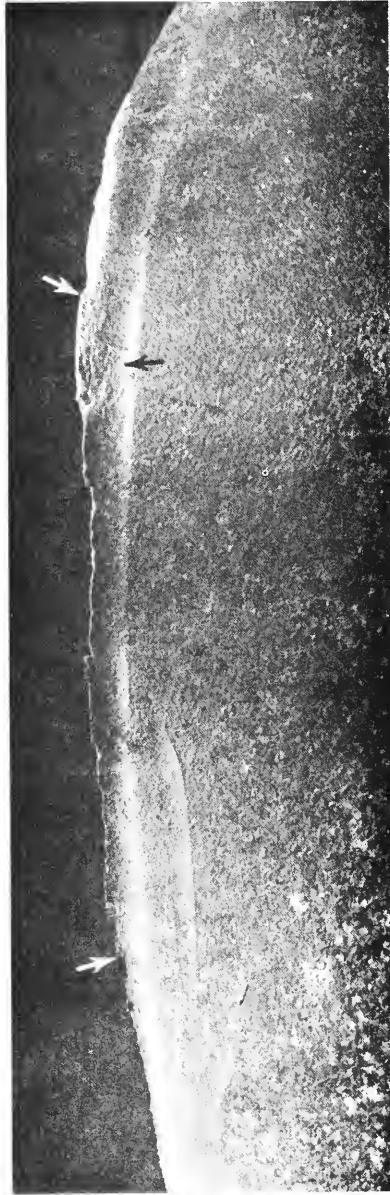
Sections for metallographic examination were cut across the fracture and gouge at four locations within the white arrows. Matching specimens were cut from above and below the fracture, mounted together, polished, and etched. The manner in which the matching fractures fit together indicate that the pipe had been dented as well as gouged. (See figure 10.) On three of the sections, small secondary cracks were found. The largest crack as shown in section B was approximately 0.015 inch deep. It was very straight for a depth of about 0.008 inch, then veered off at an angle. The offset in the fracture at the outside surface was similar in shape to the small crack. (See figure 9.)

Figure 9. Outside surface showing gouge along the fracture. The white arrows indicate the location of flat fracture; the black arrows indicate secondary cracks.

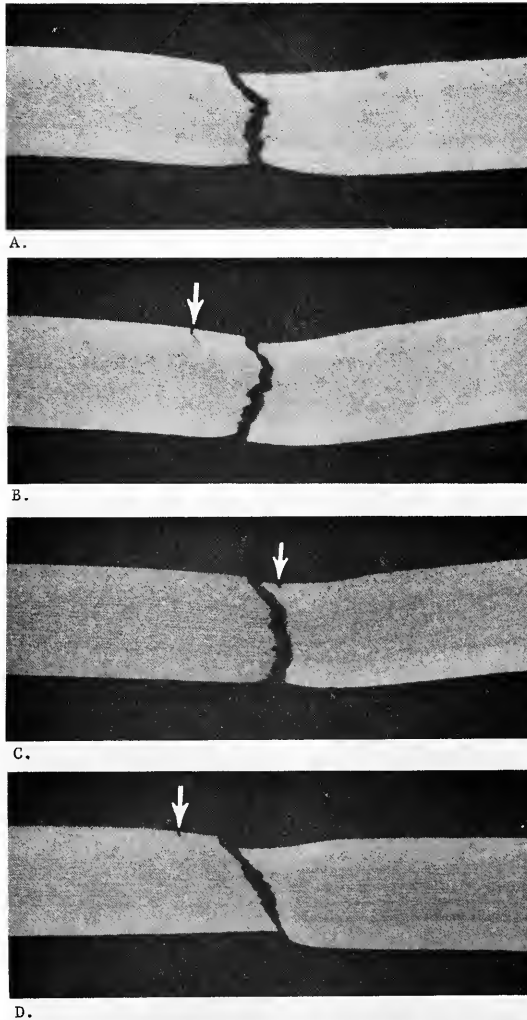
Figure 10. Sections across the rupture origin at four locations. A and B are from the right one-third of the origin; C is near the center, and D is near the left end where the fracture was changing from flat to 45-degree shear. The top of the fracture is at left. The arrows indicate secondary cracks.
